**Flood Control Project Maintenance
Levee Inspections**

2008 Channel Summary Report

Merced Irrigation District

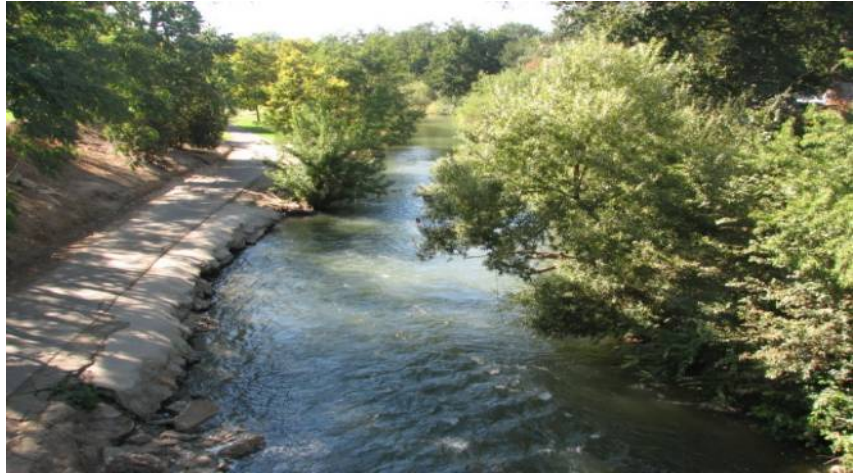
Report Line	3
Location	
Category	Rivers, Channels & Designated Floodways
Item	Vegetation & Obstructions

Looking downstream from "G" street

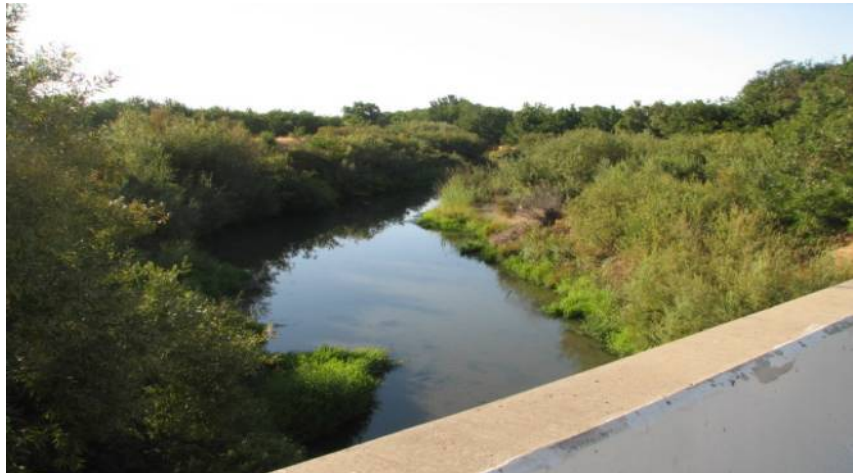
Report Line	4
Location	
Category	Rivers, Channels & Designated Floodways
Item	Vegetation & Obstructions

Looking downstream from Arboleda Drive

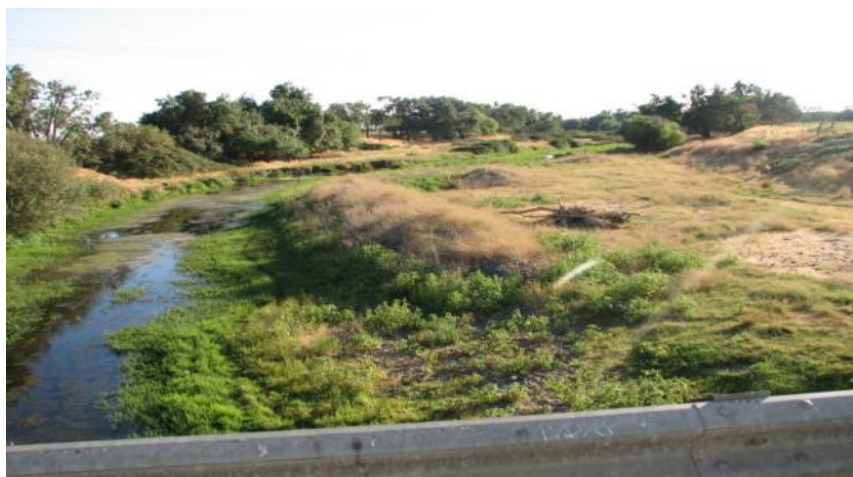
Report Line	5
Location	
Category	Rivers, Channels & Designated Floodways
Item	Vegetation & Obstructions

Looking downstream from Bonner Rd.

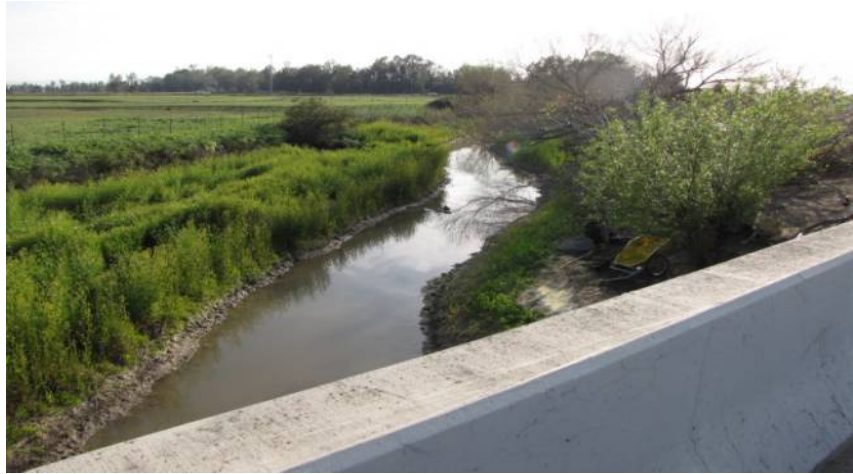
Report Line	1
Location	
Category	Rivers, Channels & Designated Floodways
Item	Vegetation & Obstructions

Looking downstream Black Rascal Creek from Santa Fe Drive.

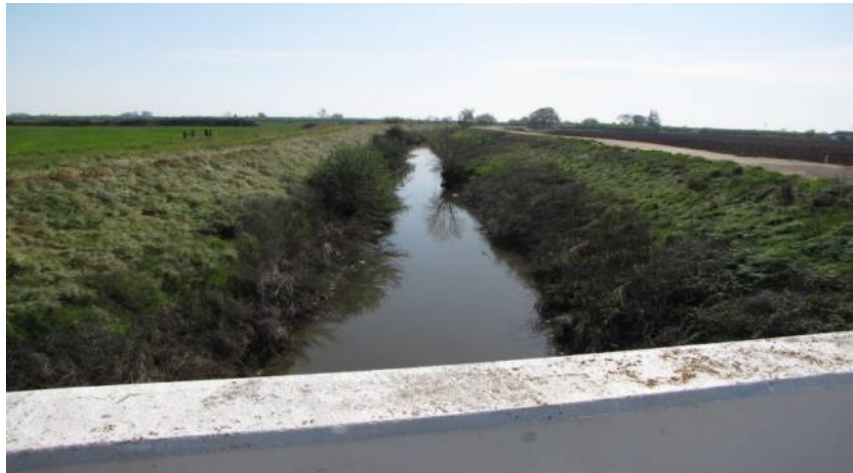
Report Line	2
Location	
Category	Rivers, Channels & Designated Floodways
Item	Vegetation & Obstructions

Looking upstream Gurr Road Crossing.

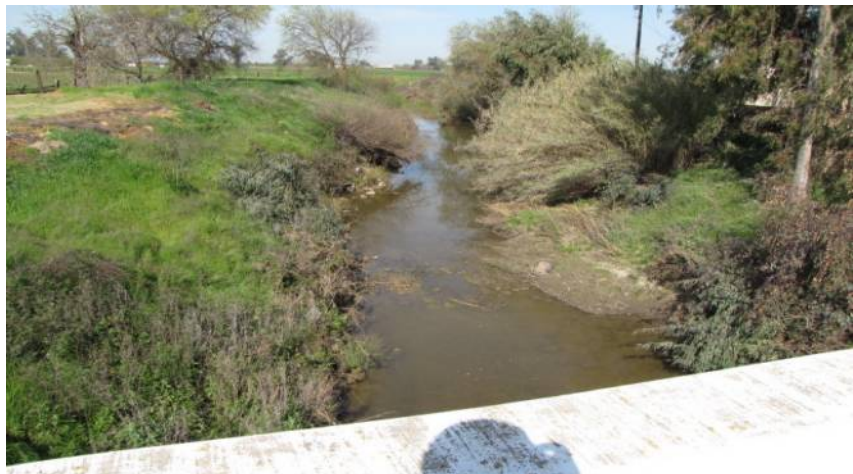
Report Line	3
Location	
Category	Rivers, Channels & Designated Floodways
Item	Vegetation & Obstructions

Looking downstream Black Rascal Creek from Gurr Road Crossing.

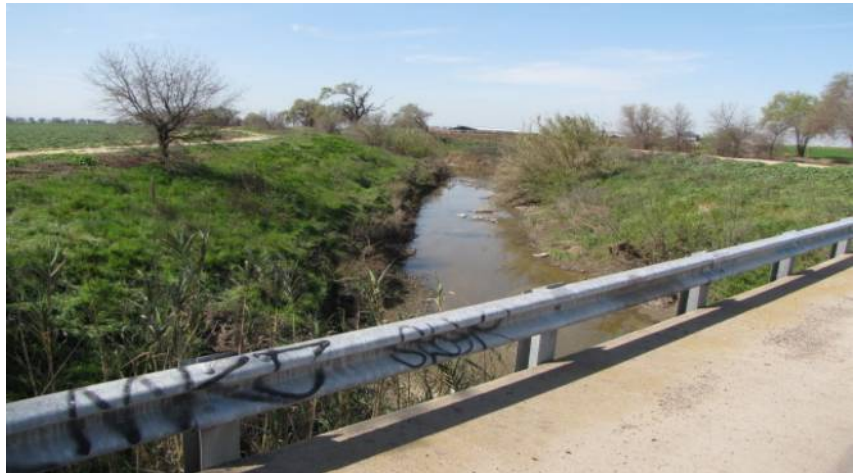
Report Line	8
Location	
Category	Rivers, Channels & Designated Floodways
Item	Vegetation & Obstructions

Looking downstream Black Rascal Creek from Quinley Road Bridge.

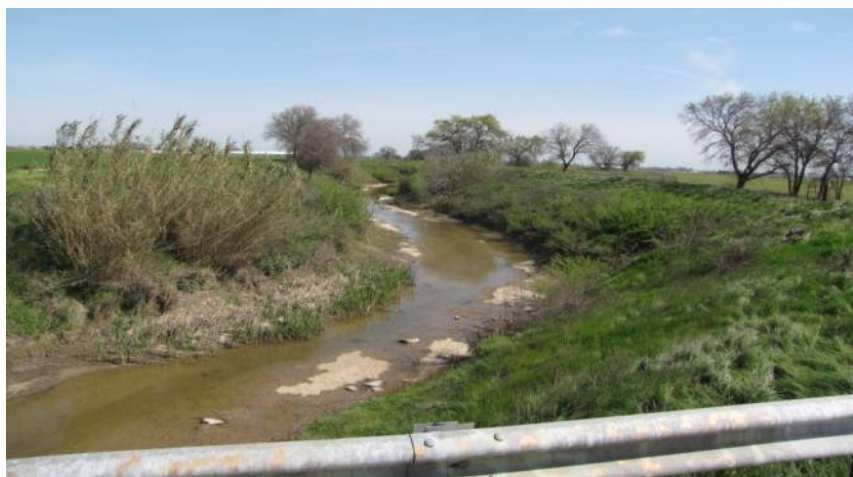
Report Line	9
Location	
Category	Rivers, Channels & Designated Floodways
Item	Vegetation & Obstructions

Looking downstream Black Rascal Creek from Oak Avenue Bridge.

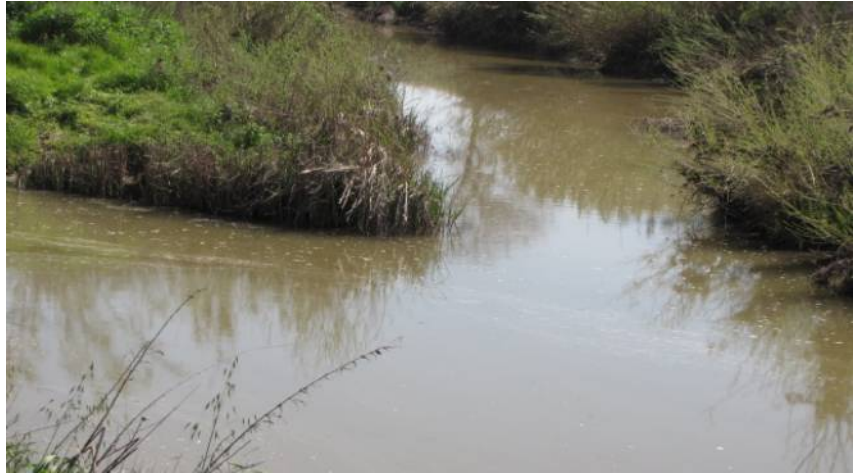
Report Line	10
Location	
Category	Rivers, Channels & Designated Floodways
Item	Vegetation & Obstructions

Looking at the confluence of the Bear Creek (right bank) with Black Rascal Creek (left bank) .

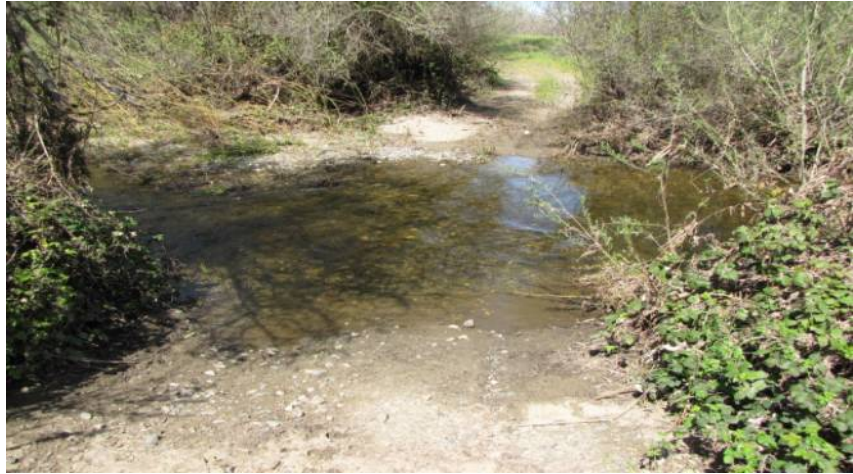
Report Line	1
Location	
Category	Rivers, Channels & Designated Floodways
Item	Vegetation & Obstructions

Looking at Burns Creek low water crossing up stream on the confluence of the Bear Creek.

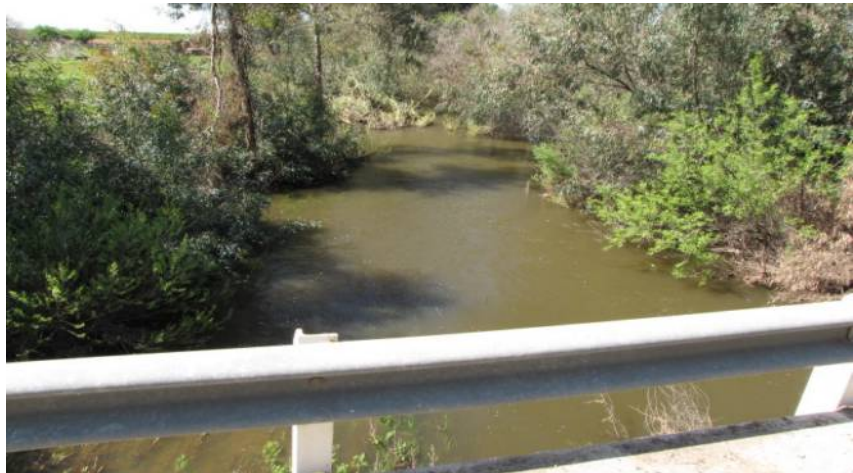
Report Line	2
Location	Water Side
Category	Rivers, Channels & Designated Floodways
Item	Vegetation & Obstructions

Looking downstream Mariposa Creek from Fresno Rd.

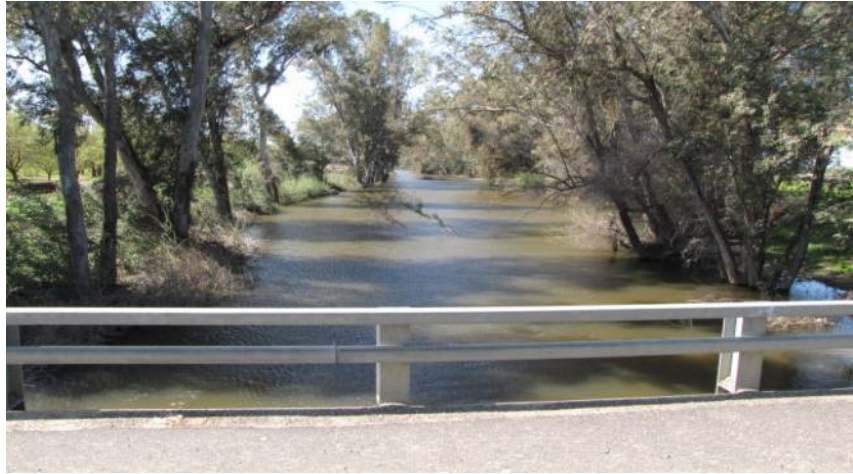
Report Line	4
Location	Water Side
Category	Rivers, Channels & Designated Floodways
Item	Vegetation & Obstructions

Looking downstream Mariposa Creek from Cunningham Rd.

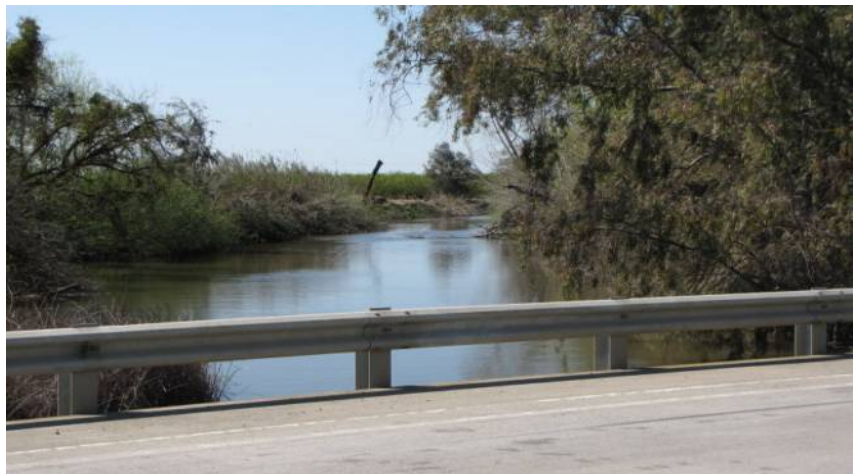
Report Line	6
Location	Water Side
Category	Rivers, Channels & Designated Floodways
Item	Vegetation & Obstructions

Looking downstream Mariposa Creek from Santa Fe Avenue.

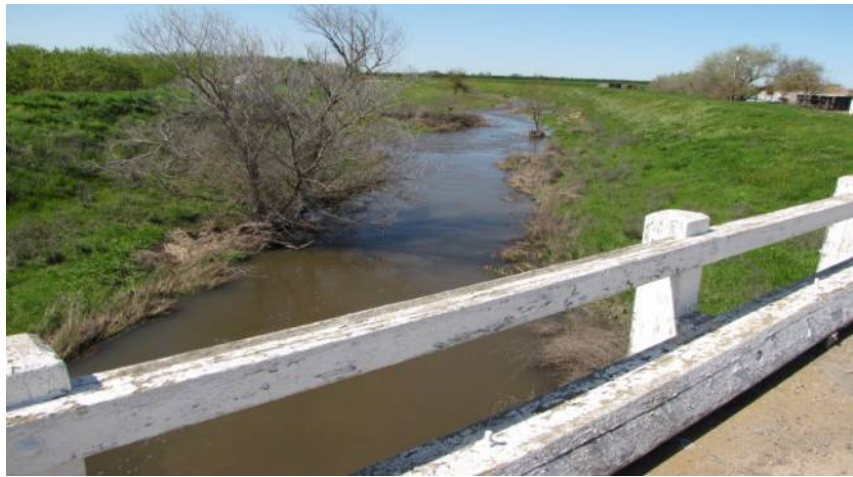
Report Line	8
Location	Water Side
Category	Rivers, Channels & Designated Floodways
Item	Vegetation & Obstructions

Looking downstream Mariposa Creek from Burchell Avenue.

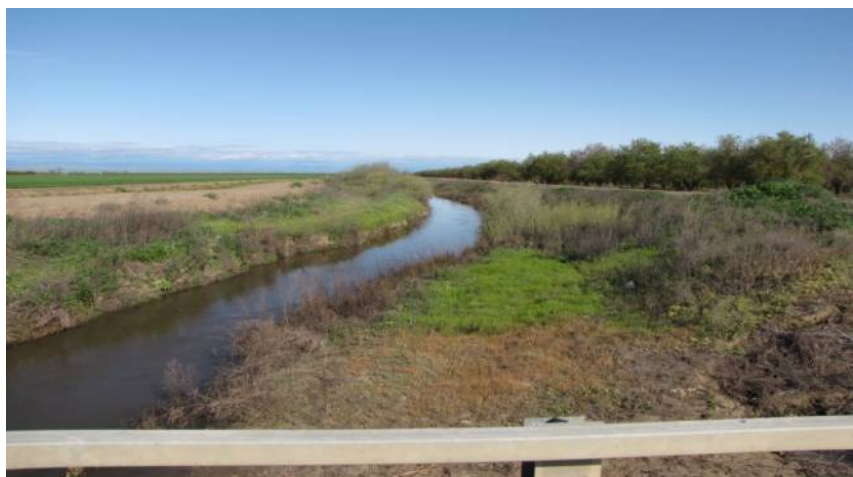
Report Line	10
Location	Water Side
Category	Rivers, Channels & Designated Floodways
Item	Vegetation & Obstructions

Looking upstream Mariposa Creek from Plainsburg Rd.

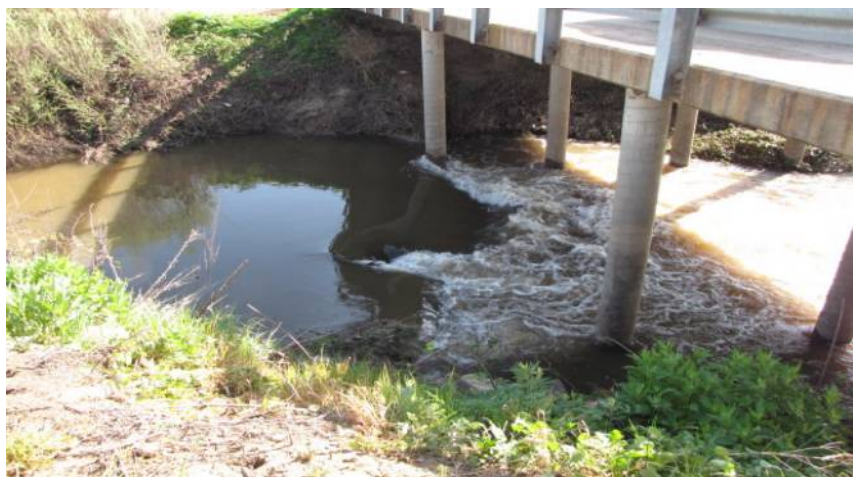
Report Line	13
Location	Water Side
Category	Rivers, Channels & Designated Floodways
Item	Vegetation & Obstructions
Upstream side of Mariposa Creek at Whealan Rd crossing.

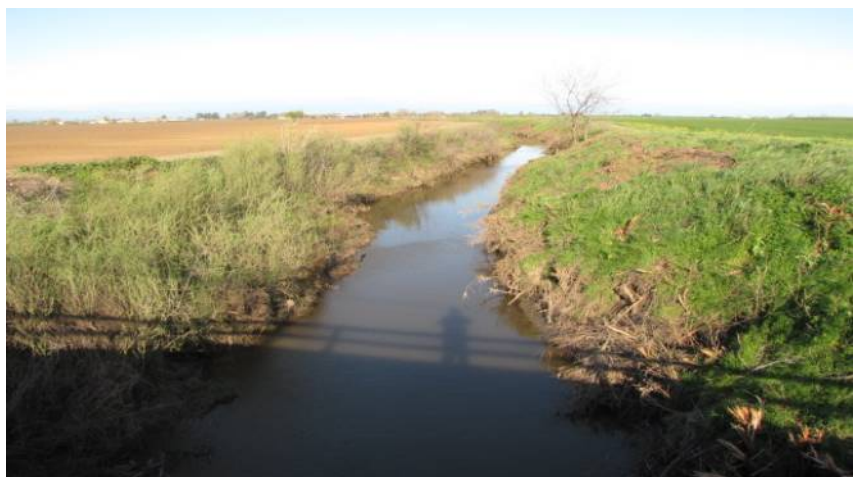
Report Line	16
Location	Water Side
Category	Rivers, Channels & Designated Floodways
Item	Vegetation & Obstructions

Looking upstream Mariposa Creek from Heay Road.

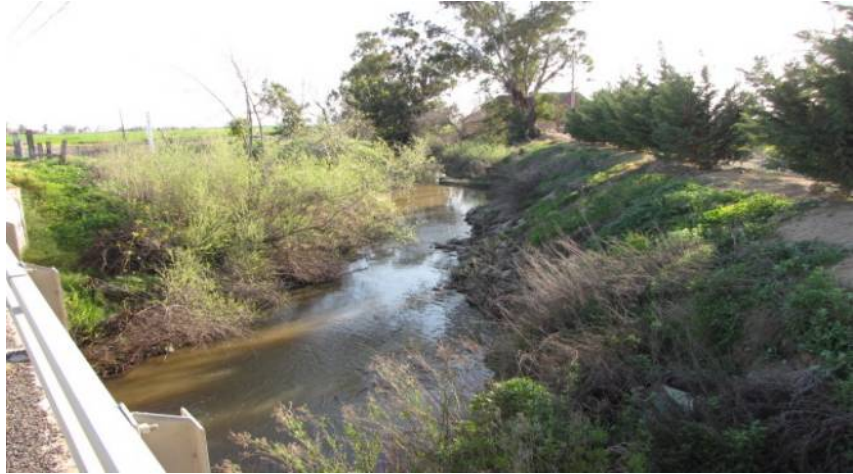
Report Line	17
Location	Water Side
Category	Rivers, Channels & Designated Floodways
Item	Vegetation & Obstructions
Looking downstream Mariposa Creek from Healy Road.

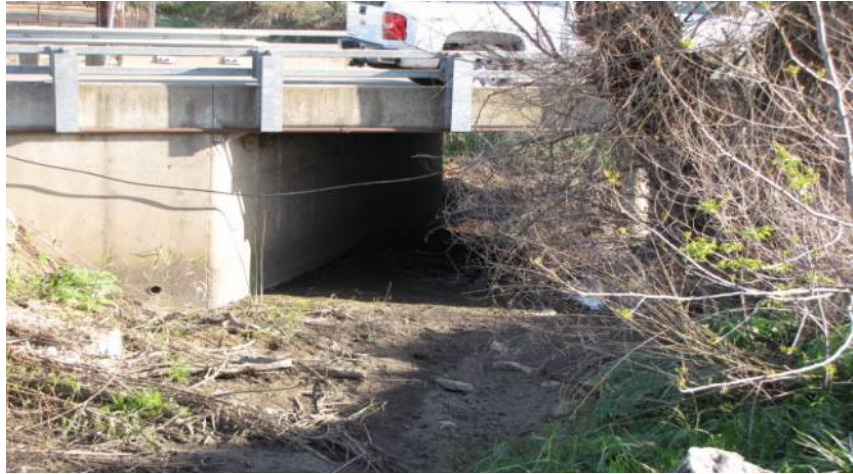
Report Line	4
Location	
Category	Rivers, Channels & Designated Floodways
Item	Vegetation & Obstructions
Looking upstream Miles Creek at Reilly Road crossing.

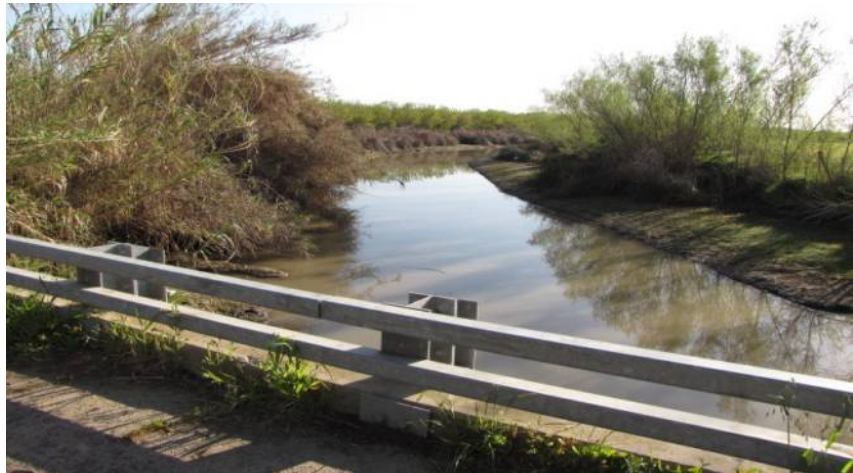
Report Line	5
Location	
Category	Rivers, Channels & Designated Floodways
Item	Vegetation & Obstructions
Looking upstream Miles Creek from Tyler Road.

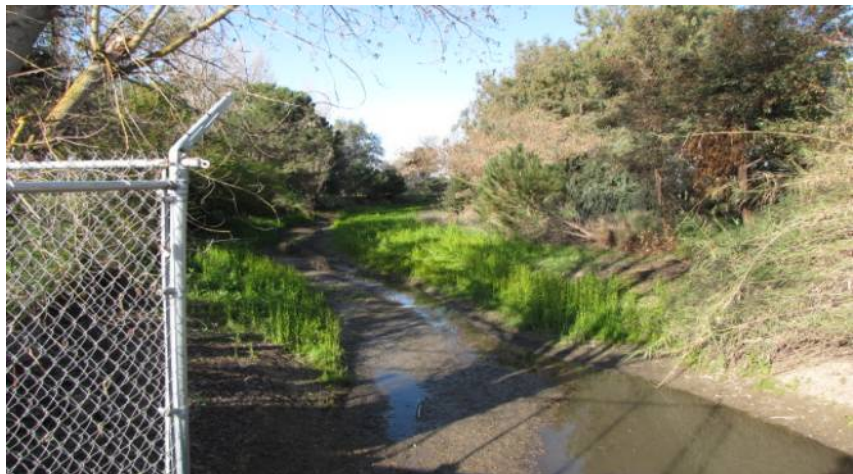
Report Line	6
Location	
Category	Rivers, Channels & Designated Floodways
Item	Vegetation & Obstructions
Looking downstream Miles Creek from Tyler Road.

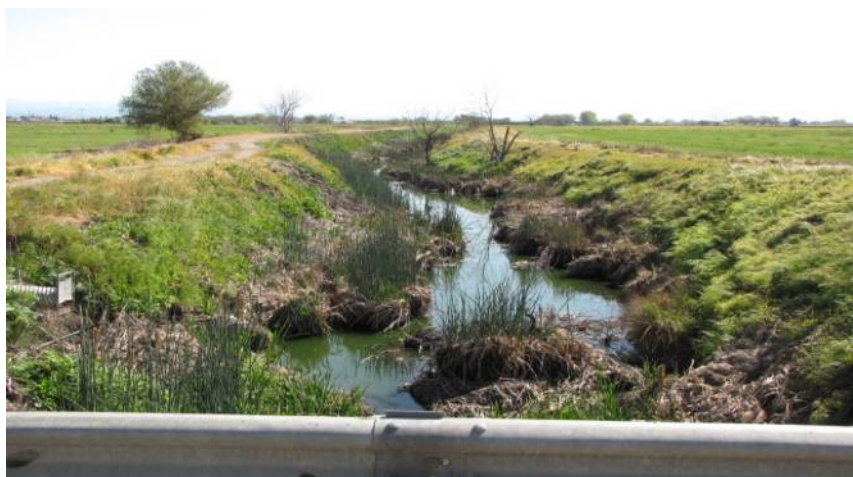
Report Line	8
Location	
Category	Rivers, Channels & Designated Floodways
Item	Vegetation & Obstructions

Looking downstream Miles Creek from Wheak Road.

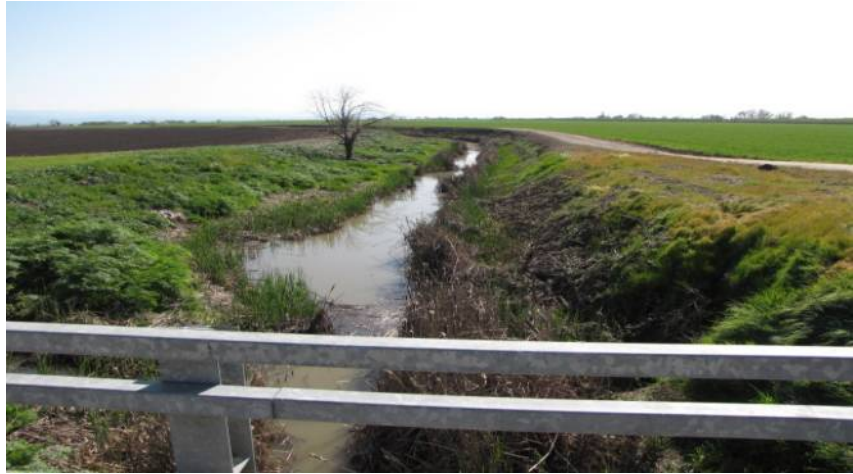
Report Line	9
Location	
Category	Rivers, Channels & Designated Floodways
Item	Vegetation & Obstructions

Looking upstream Miles Creek from Orchard Drive.

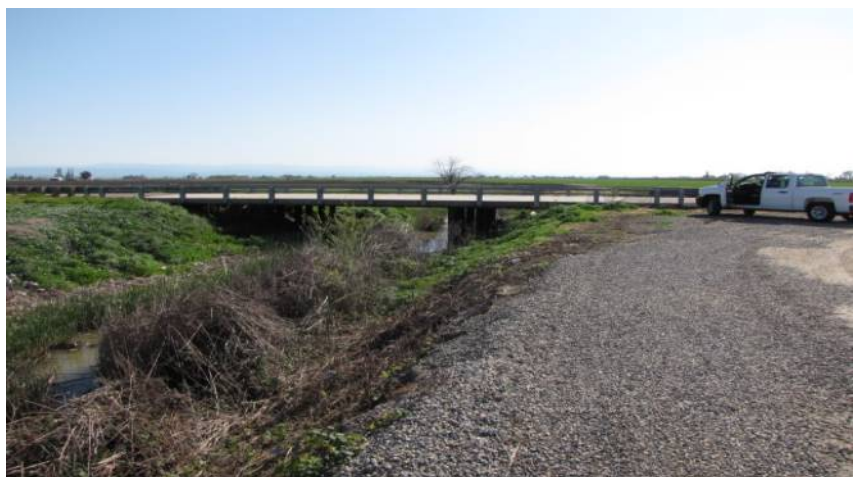
Report Line	11
Location	
Category	Rivers, Channels & Designated Floodways
Item	Vegetation & Obstructions

Looking upstream Miles Creek at Orchard Drive crossing from (left bank).

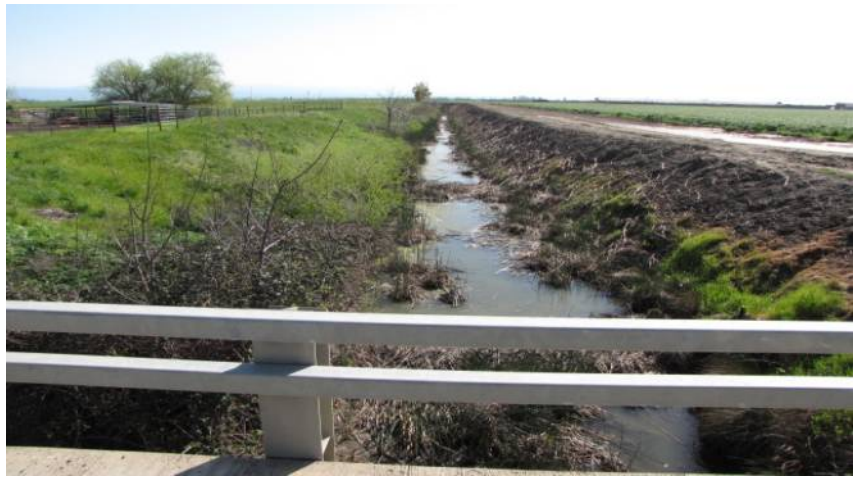
Report Line	12
Location	
Category	Rivers, Channels & Designated Floodways
Item	Vegetation & Obstructions
Looking upstream Miles Creek from Arboleda Drive.

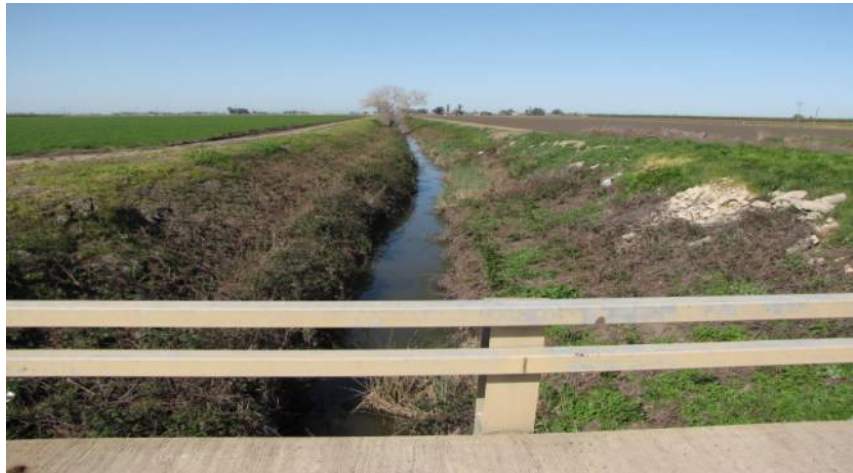
Report Line	13
Location	
Category	Rivers, Channels & Designated Floodways
Item	Vegetation & Obstructions
Looking downstream Miles Creek from Arboleda Drive.

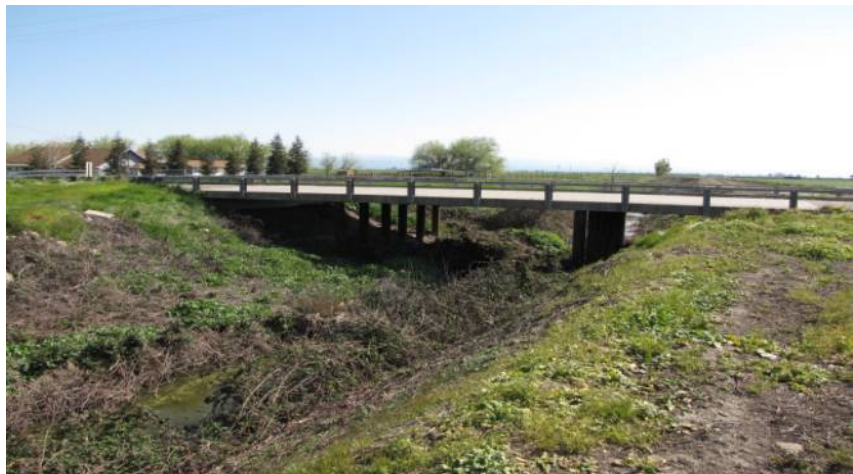
Report Line	14
Location	
Category	Rivers, Channels & Designated Floodways
Item	Vegetation & Obstructions
Looking upstream Miles Creek at Arboleda Drive crossing.

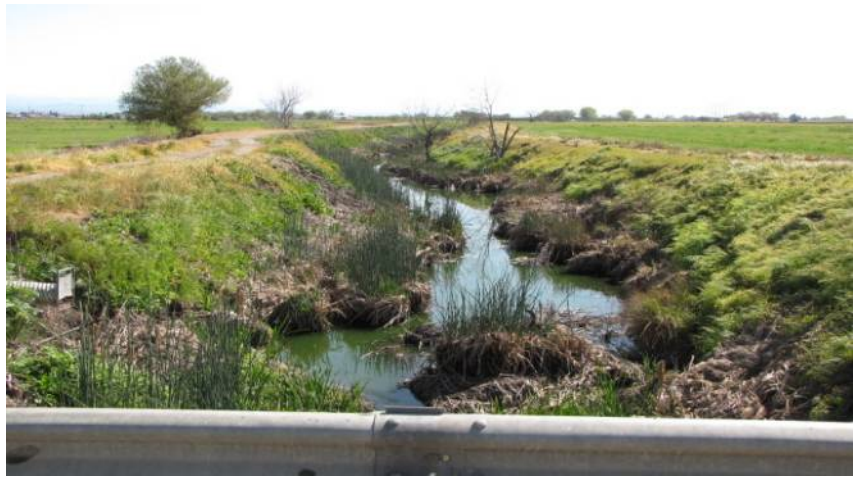
Report Line	15
Location	
Category	Rivers, Channels & Designated Floodways
Item	Vegetation & Obstructions

Looking upstream Miles Creek from Whealan Road

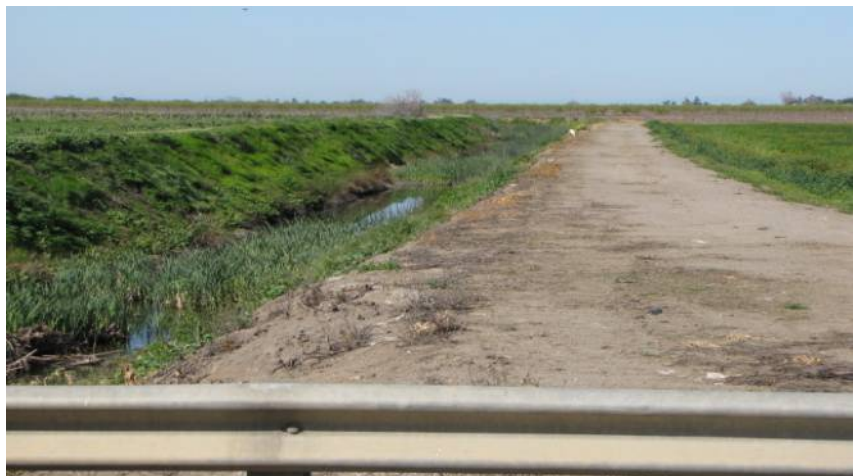
Report Line	16
Location	
Category	Rivers, Channels & Designated Floodways
Item	Vegetation & Obstructions

Looking downstream Miles Creek from Whealan Road

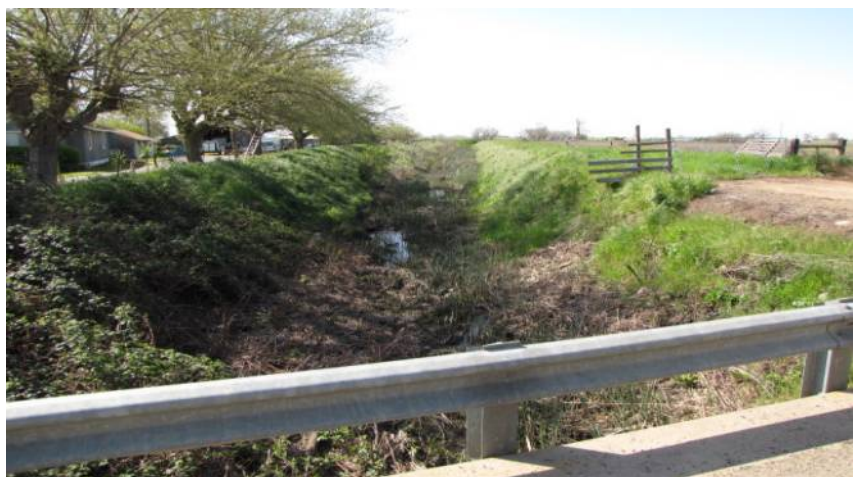
Report Line	17
Location	
Category	Rivers, Channels & Designated Floodways
Item	Vegetation & Obstructions

Looking downstream Miles Creek from Gerard Ave.

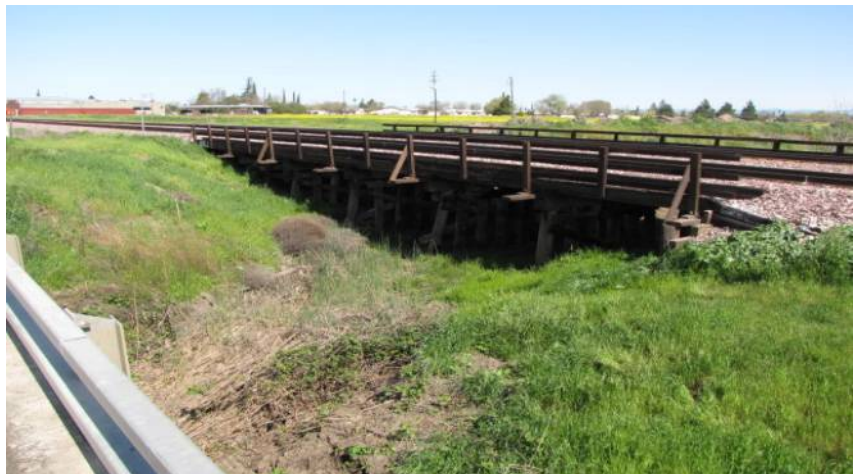
Report Line	20
Location	
Category	Rivers, Channels & Designated Floodways
Item	Vegetation & Obstructions
Looking upstream Miles Creek from Santa Fe Avenue.

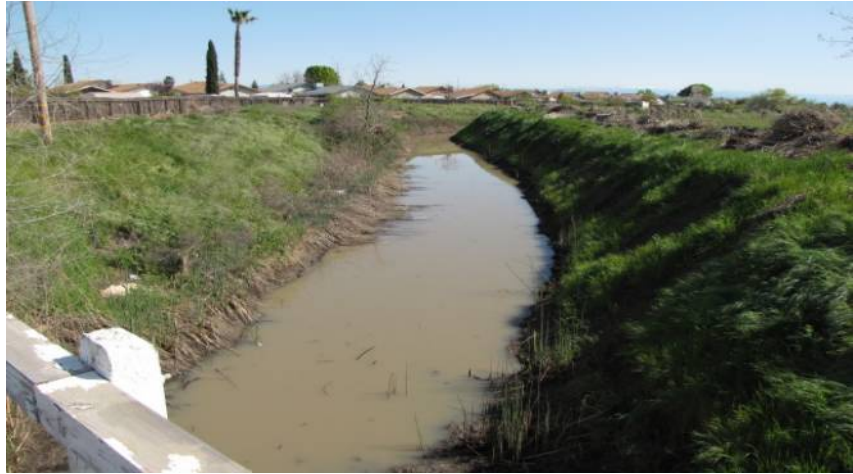
Report Line	21
Location	
Category	Rivers, Channels & Designated Floodways
Item	Vegetation & Obstructions

Looking upstream Miles Creek from Plainsburg bridge

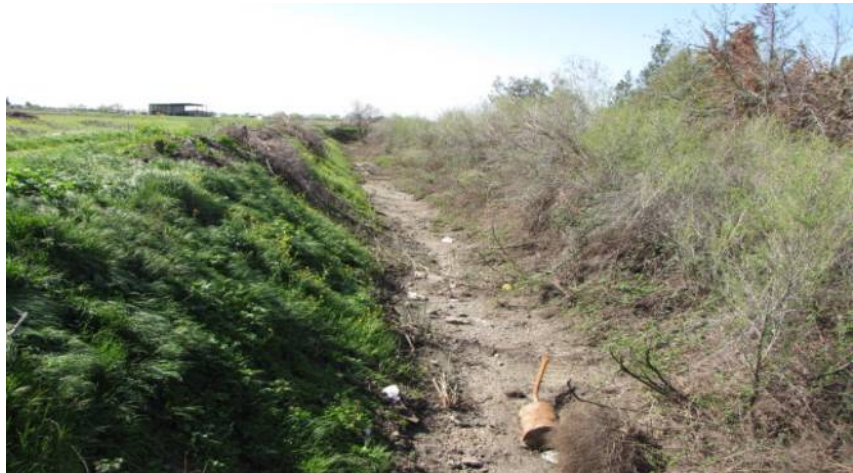
Report Line	22
Location	
Category	Rivers, Channels & Designated Floodways
Item	Vegetation & Obstructions

Looking downstream Miles Creek from Santa Fe Avenue.

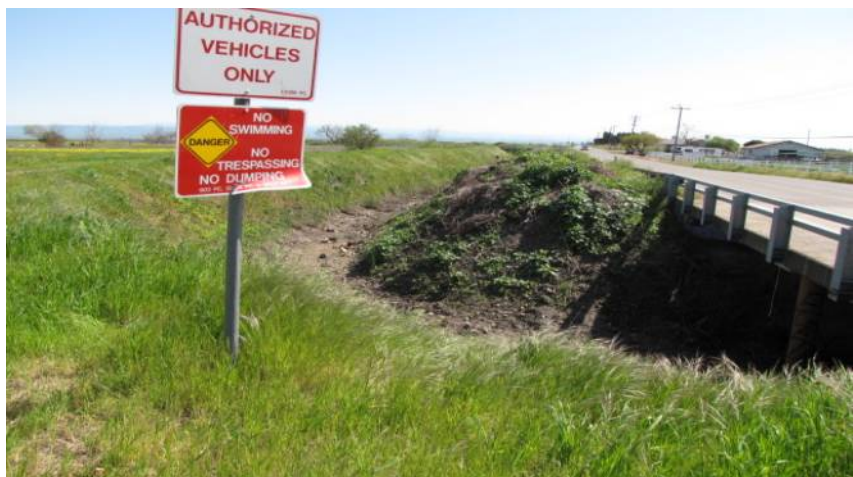
Report Line	23
Location	
Category	Rivers, Channels & Designated Floodways
Item	Vegetation & Obstructions

Looking upstream Miles Creek from Childs Avenue.

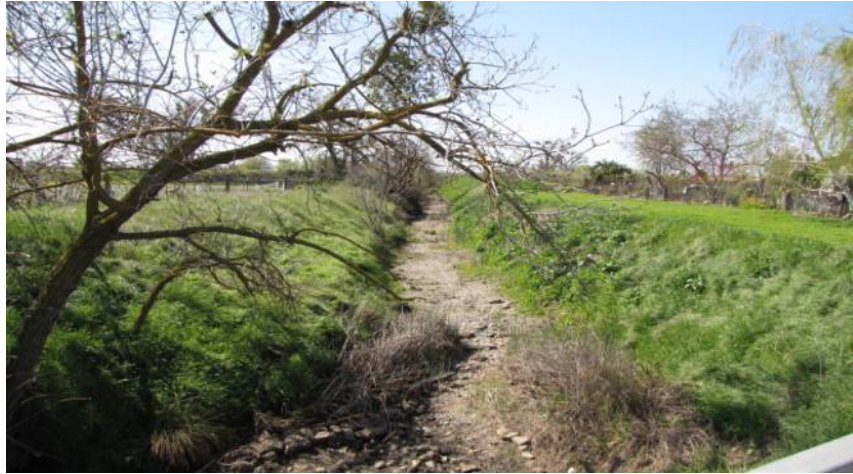
Report Line	24
Location	
Category	Rivers, Channels & Designated Floodways
Item	Vegetation & Obstructions

Looking downstream Miles Creek from Childs Avenue.

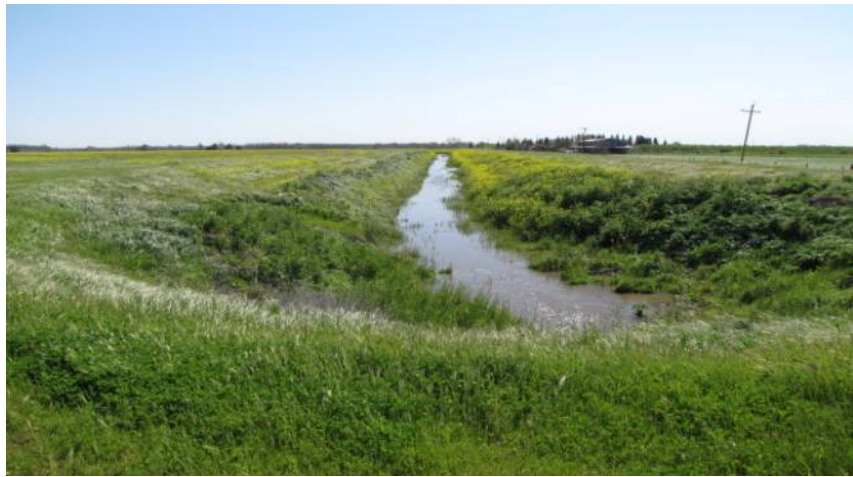
Report Line	1
Location	
Category	Rivers, Channels & Designated Floodways
Item	Vegetation & Obstructions

Looking downstream Owens Creek Diversion Channel from Santa Fe Avenue.

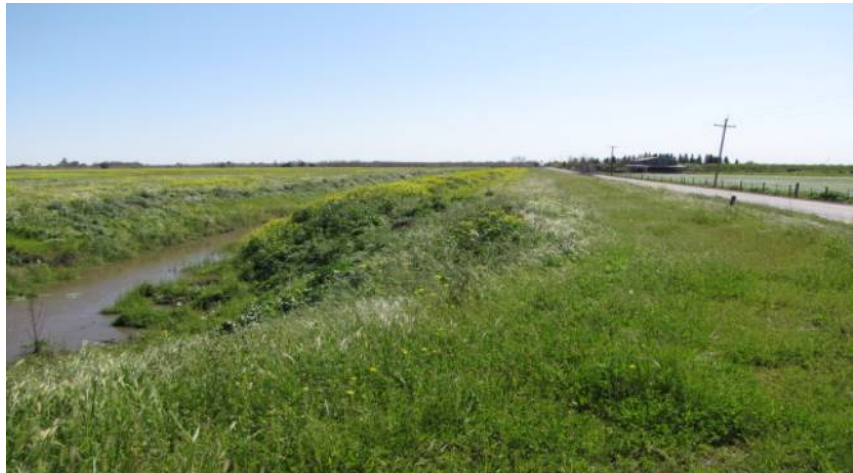
Report Line	2
Location	
Category	Rivers, Channels & Designated Floodways
Item	Vegetation & Obstructions

Looking Downstream Unit 1 (right bank levee) of Owens Creek Diversion Channel from Santa Fe Avenue.

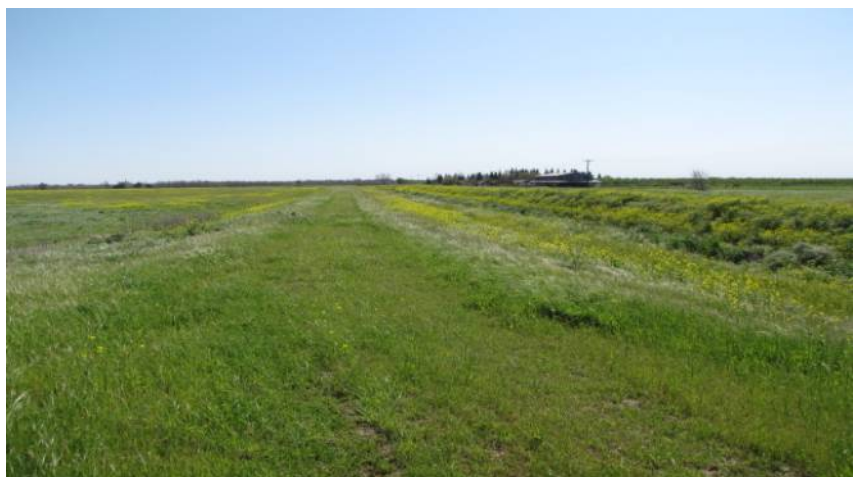
Report Line	3
Location	
Category	Rivers, Channels & Designated Floodways
Item	Vegetation & Obstructions

Looking downstream Unit 2 (left bank levee) of Owens Creek Diversion Channel from Santa Fe Avenue.

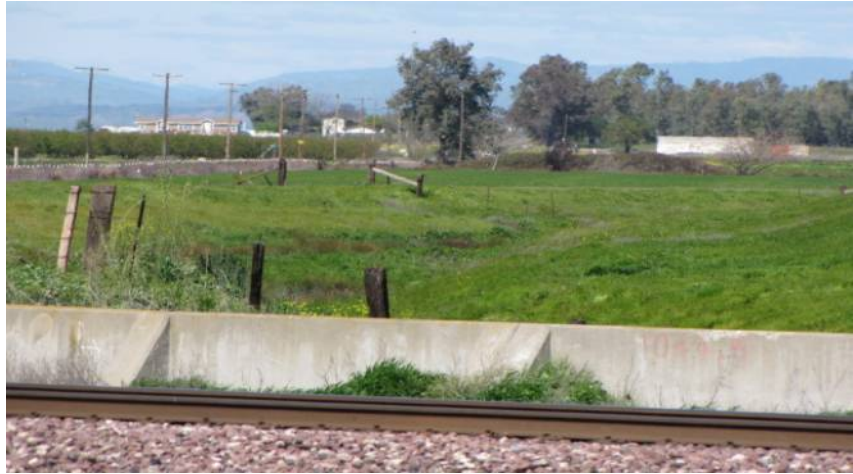
Report Line	4
Location	
Category	Rivers, Channels & Designated Floodways
Item	Vegetation & Obstructions

Looking from railroad crossing upstream from inlet structure.

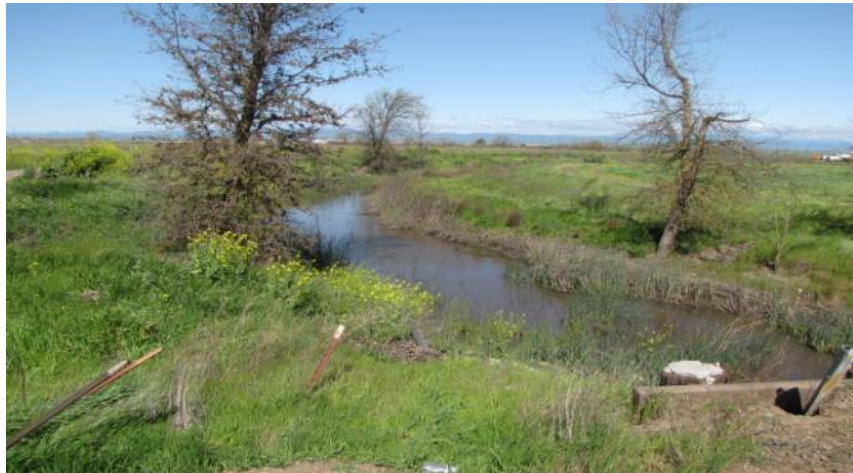
Report Line	5
Location	
Category	Rivers, Channels & Designated Floodways
Item	Vegetation & Obstructions

Looking upsream Owens Creek Diversion Channel from Mission Avenue.

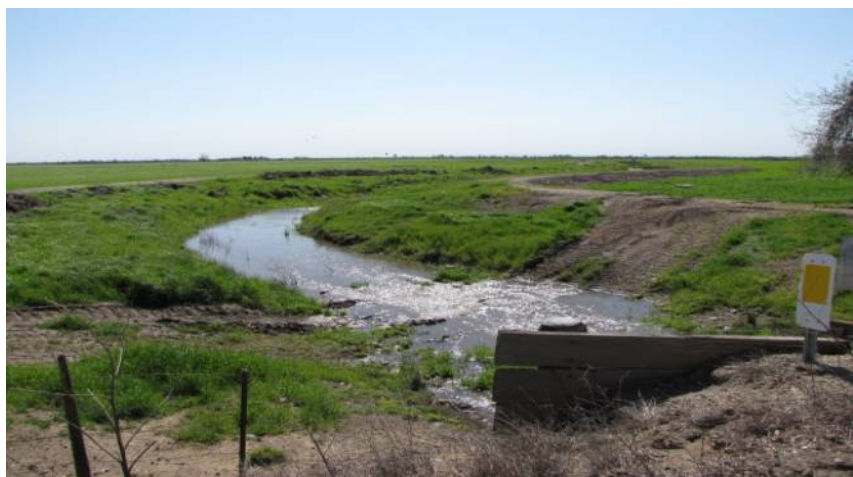
Report Line	6
Location	
Category	Rivers, Channels & Designated Floodways
Item	Vegetation & Obstructions

Looking downstream Owens Creek Diversion Channel from Mission Avenue.

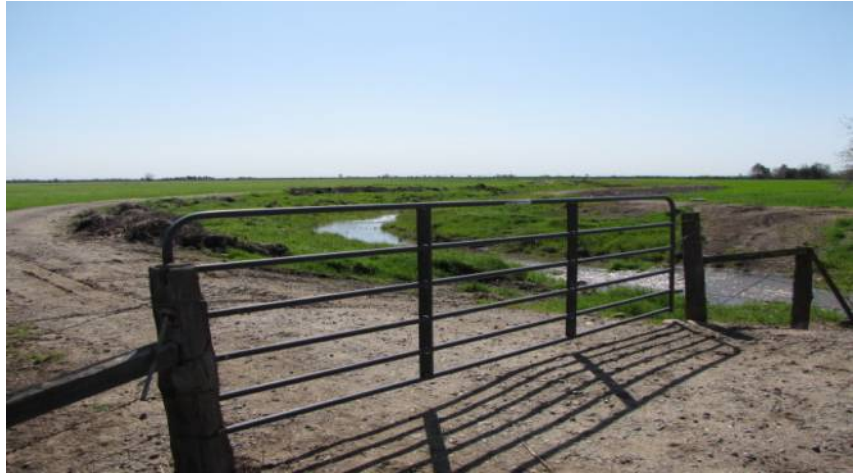
Report Line	7
Location	
Category	Rivers, Channels & Designated Floodways
Item	Vegetation & Obstructions

Looking downstream Unit 2 of Owens Creek Diversion Channel from Mission Avenue.
